Holiday Inn Leeds - Garforth Banqueting Suite

Guide Last Updated: 24/10/2017

Access Guide

Conference Facilities Introduction (Banqueting Suite)

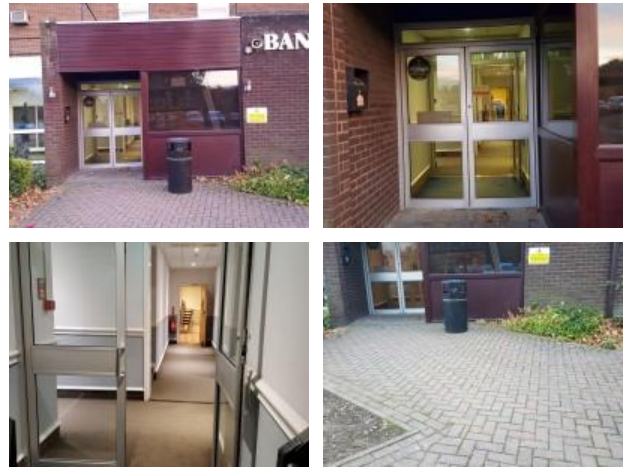
Outside Access (Banqueting Suite External Entrance)

<p>Entrance Collapse -</p> <ul style="list-style-type: none"> • This information is for the entrance located at the front right of the hotel. • The entrance area/door is clearly signed. • There is ramped/sloped access at this entrance. • There is a canopy or recess which provides weather protection at this entrance. • The entrance door(s) does/do contrast visually with its immediate surroundings. • The main door(s) open(s) away from you (push). • The door(s) is/are double width. • The door(s) is/are heavy. • The width of the door opening is 148cm. • There is a second set of doors. • The door(s) open(s) towards you (pull). • The door(s) is/are double width. • The door(s) is/are heavy. • The width of the door opening is 142cm. • There is a member of staff available for assistance at this entrance.
<p>Ramp/Slope Collapse -</p> <ul style="list-style-type: none"> • The ramp/slope is located on the path leading to the entrance. • The gradient of the ramp/slope is slight.

<p>Comments Collapse -</p> <ul style="list-style-type: none"> • This entrance is normally kept locked and can only be used upon request. • Using this entrance avoids the front right corridor stairs and platform lift. • To use this entrance please see a member of staff on the main reception desk.

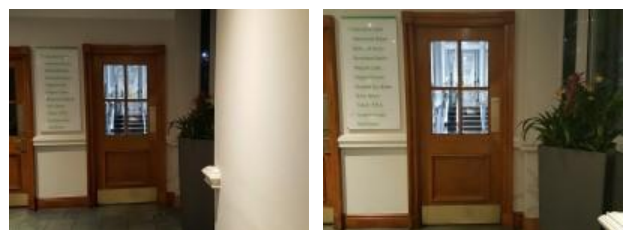
Entrance (Banqueting Suite Internal Entrance From Hotel)

<p>Entrance Collapse -</p> <ul style="list-style-type: none"> • This information is for the entrance located to the right as you enter the main hotel. • The entrance area/door is clearly signed. • There is step free access at this entrance. <p>Cookie Policy</p>

- The entrance door(s) does/do contrast visually with its immediate surroundings.
- The main door(s) open(s) away from you (push).
- The door(s) is/are single width.
- The door(s) is/are permanently held open.
- The width of the door opening is 78cm.

- This is the usual entrance to the Banqueting Suite.
- Using this entrance means having to use the front right corridor steps or platform lift.
- To avoid using the steps/platform lift please see a member of staff at the hotel main reception desk.
- A member of staff will then unlock the main Banqueting Suite entrance.

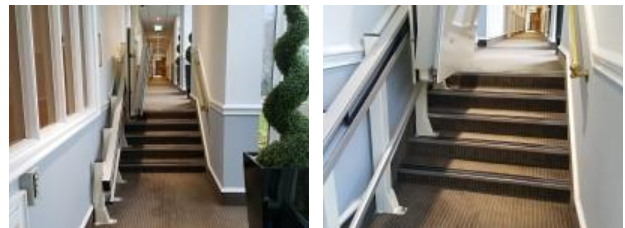
Step(s) (Front Right Corridor)

- There is a/are step(s) located on the ground floor, at the front right of the hotel.
- The step(s) is/are used to access These steps access some of the executives suites and conference rooms and the accessible toilets.
- There is/are 5 step(s).
- The step(s) is/are clearly marked.
- The height of the step(s) is/are between 15cm and 18cm.
- The going of the step(s) is/are not between 30cm and 45cm.
- There is a/are handrail(s) at the step(s).
- The handrail(s) is/are on the right going up.
- Handrails are at the recommended height (90cm-100cm).
- Handrails do cover the flight of stairs throughout its length.
- Handrails are easy to grip.
- Handrails do not extend horizontally beyond the first and last steps.
- The lighting levels at the step(s) are good.

- These steps lead from the hotel to the Banqueting Suite area.

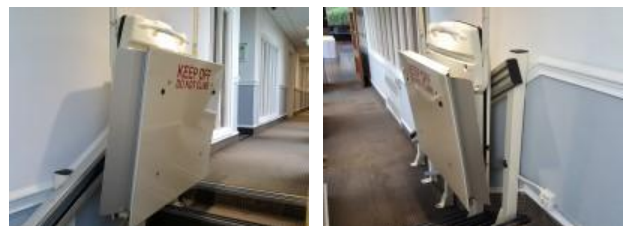
Lift (Front Right Corridor Platform Lift)

- There is a lift for public use.
- The lift is located on the ground floor, at the front right of the hotel.
- Signs indicating the location of the lift are not available from the entrance.
- The lift is approximately 10m (10yd 2ft) from the hotel entrance.
- The lift is a platform lift.
- A member of staff needs to be notified for use of the lift.
- A member of staff is required to operate the lift.
- The platform lift accesses a small level change.

- Clear signs indicating the facilities on each floor are not provided on lift lobby landings.
- There is not a clear level manoeuvring space of 150cm x 150cm in front of the lift.

- The external controls for the lift are not within 90cm - 110cm from the floor.
- The colour contrast between the external lift controls and the control plate is poor.

- The colour contrast between the external lift control plate and the wall is poor.
- The clear door width is 78cm (2ft 7in).
- The dimensions of the lift are 78cm x 95cm (2ft 7in x 3ft 1in).

- There are separate entry and exit doors in the lift.
- The lift does not have a visual floor indicator.
- The lift does not have an audible announcer.
- The controls for the lift are not within 90cm - 120cm from the floor.

- The lift controls are within 80cm - 92cm from the floor.
- There is not a hearing loop system.
- The lift does not have Braille markings.
- The lift does not have tactile markings.

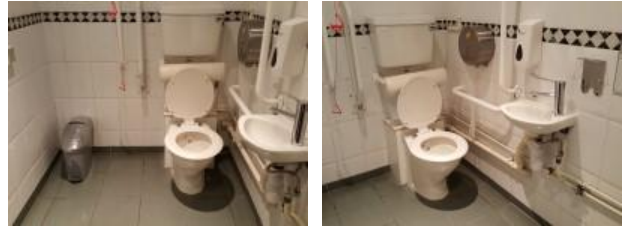
Accessible Toilet(s) (Front Right Corridor)

- The accessible toilet surveyed is not for the sole use of disabled people.
- This accessible toilet is located in the front right hand corridor of the hotel, in the Banqueting Suite area.
- This accessible toilet is approximately 28m (30yd 1ft) from the hotel entrance.
- There is step free access to the accessible toilet, via lift.

- This is a shared toilet.
- A key is not required for the accessible toilet.
- There is pictorial signage on or near the toilet door.
- The door opens outwards.

- The door is heavy.
- The door is locked by a lever twist.
- The width of the accessible toilet door is 83cm (2ft 9in).
- The dimensions of the accessible toilet are 147cm x 300cm (4ft 10in x 9ft 10in).

- The accessible toilet does not have an unobstructed minimum turning space of 150cm x 150cm.
- The toilet has not got a non slip floor.
- The height of the light switch/pull cord is 113cm from floor level.

- There is a lateral transfer space.
- As you face the toilet pan the transfer space is on the left.
- The lateral transfer space is 89cm (2ft 11in).
- There is a flush, however it is not on the transfer side.

- There is not a spatula type lever flush.
- There is a dropdown rail on the transfer side.
- There is an emergency alarm.
- The emergency pull cord alarm is not fully functional.

- The alarm was out of reach (higher than 10cm (4") from floor) when surveyed.
- There is not a flashing fire alarm beacon within the toilet.
- Disposal facilities are available in the toilet.
