Holiday Inn Leeds - Garforth

Guide Last Updated: 25/10/2017

Access Guide

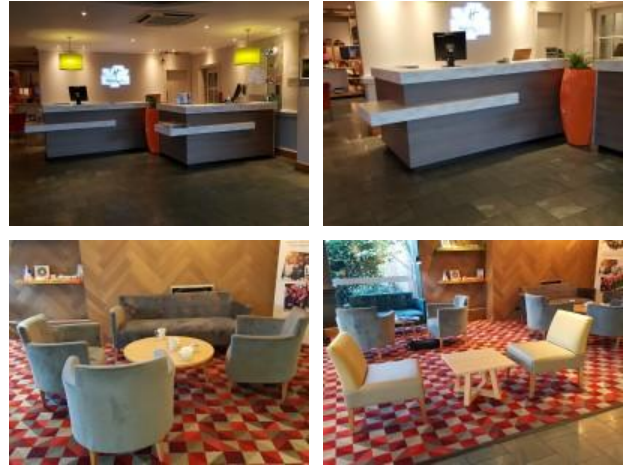
Reception

- The reception point is located ahead as you enter the hotel.
- The reception point is approximately 7m (7yd 1ft) from the hotel entrance.
- The reception area/desk is clearly visible from the entrance.

- There is step free access to the reception point.
- There is a clear unobstructed route to the reception point.
- There are no windows, TVs, glazed screens or mirrors behind the reception point which could adversely affect the ability of someone to lip read.

- The reception counter is not placed in front of a background which is patterned.
- The lighting levels at the reception point are good.
- The height of the reception counter is high (110cm+).

- There is sufficient space to write or sign documents on the counter.
- There is a lowered section of the counter.
- The lowered section of the counter is at the recommended height of 76cm.

- There is sufficient space to write or sign documents on the lowered section of the counter.
- There is a clear knee recess beneath the lowered section of the counter.

- The clear knee recess does not have the recommended dimensions of 70cm (height) x 50cm (depth).
- The counter is staffed.
- Clipboards can be provided to anyone who is unable to use the desk.

- There is not a hearing assistance system at the reception point.
- Signs and universally accepted symbols or pictograms, indicating lifts, stairs, WCs, circulation routes and other parts of the building are provided in the reception area.

- The type of flooring in the reception area is carpet and stone.

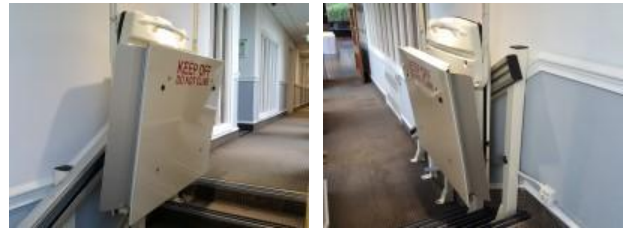
Lift (Front Right Corridor Platform Lift)

- There is a lift for public use.
- The lift is located on the ground floor, at the front right of the hotel.
- Signs indicating the location of the lift are not available from the entrance.

- The lift is approximately 10m (10yd 2ft) from the hotel entrance.
- The lift is a platform lift.
- A member of staff needs to be notified for use of the lift.

- A member of staff is required to operate the lift.
- The platform lift accesses a small level change.
- Clear signs indicating the facilities on each floor are not provided on lift lobby landings.

- There is not a clear level manoeuvring space of 150cm x 150cm in front of the lift.
- The external controls for the lift are not within 90cm - 110cm from the floor.

- The colour contrast between the external lift controls and the control plate is poor.
- The colour contrast between the external lift control plate and the wall is poor.

- The clear door width is 78cm (2ft 7in).
- The dimensions of the lift are 78cm x 95cm (2ft 7in x 3ft 1in).
- There are separate entry and exit doors in the lift.

- The lift does not have a visual floor indicator.
- The lift does not have an audible announcer.
- The controls for the lift are not within 90cm - 120cm from the floor.

- The lift controls are within 80cm - 92cm from the floor.
- There is not a hearing loop system.
- The lift does not have Braille markings.
- The lift does not have tactile markings.

- The lighting levels in the lift are good.
- There is a/are similar lift(s) available.

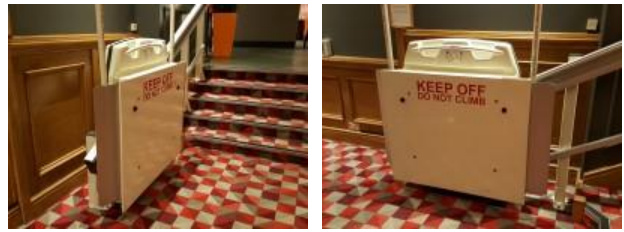
Lift (Left Hand Corridor First Platform Lift)

- There is a lift for public use.
- The lift is located on the ground floor, in the corridor to the left of reception.
- Signs indicating the location of the lift are not available from the entrance.

- The lift is approximately 11m (12yd 1in) from the hotel entrance.
- The lift is a platform lift.
- A member of staff needs to be notified for use of the lift.

- A member of staff is required to operate the lift.
- The platform lift accesses a small level change.
- Clear signs indicating the facilities on each floor are provided on lift lobby landings.

- There is a clear level manoeuvring space of 150cm x 150cm in front of the lift.
- The external controls for the lift are within 90cm - 110cm from the floor.

- The colour contrast between the external lift controls and the control plate is poor.
- The colour contrast between the external lift control plate and the wall is good.

- The clear door width is 78cm (2ft 7in).
- The dimensions of the lift are 78cm x 93cm (2ft 7in x 3ft 1in).
- There are separate entry and exit doors in the lift.

- The lift does not have a visual floor indicator.
- The lift does not have an audible announcer.
- The controls for the lift are within 90cm - 120cm from the floor.

- There is not a hearing loop system.
- The lift does not have Braille markings.
- The lift does not have tactile markings.
- The lighting levels in the lift are good.

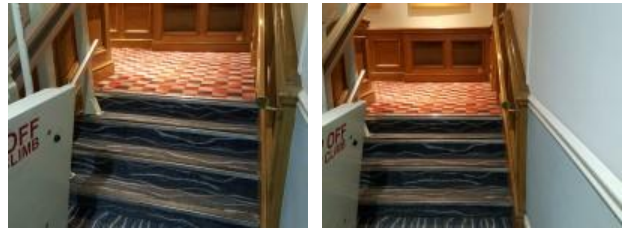
Step(s) (Left Hand Corridor Second Set of Steps)

- There is a/are step(s) located on the ground floor, in the left hand corridor.
- The step(s) is/are used to access rooms, meeting rooms and the internal entrance to the leisure facilities.
- There is/are 4 step(s).
- The step(s) is/are clearly marked.
- The height of the step(s) is/are between 15cm and 18cm.
- The going of the step(s) is/are not between 30cm and 45cm.
- There is a/are handrail(s) at the step(s).
- The handrail(s) is/are on the right going up.
- Handrails are at the recommended height (90cm-100cm).
- Handrails do cover the flight of stairs throughout its length.
- Handrails are easy to grip.
- Handrails do not extend horizontally beyond the first and last steps.
- The lighting levels at the step(s) are good.

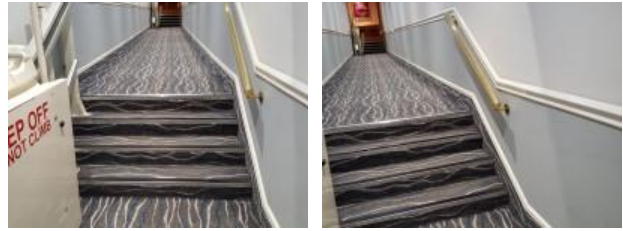
Step(s) (Left Hand Corridor Third Set of Steps)

- There is a/are step(s) located on the ground floor, in the centre of the left hand corridor.
- The step(s) is/are used to access rooms, meeting rooms and the internal entrance to the leisure facilities.
- There is/are 4 step(s).
- The step(s) is/are clearly marked.
- The height of the step(s) is/are between 15cm and 18cm.
- The going of the step(s) is/are not between 30cm and 45cm.
- There is a/are handrail(s) at the step(s).
- The handrail(s) is/are on the right going up.
- Handrails are at the recommended height (90cm-100cm).
- Handrails do cover the flight of stairs throughout its length.
- Handrails are easy to grip.
- Handrails do not extend horizontally beyond the first and last steps.
- The lighting levels at the step(s) are good.

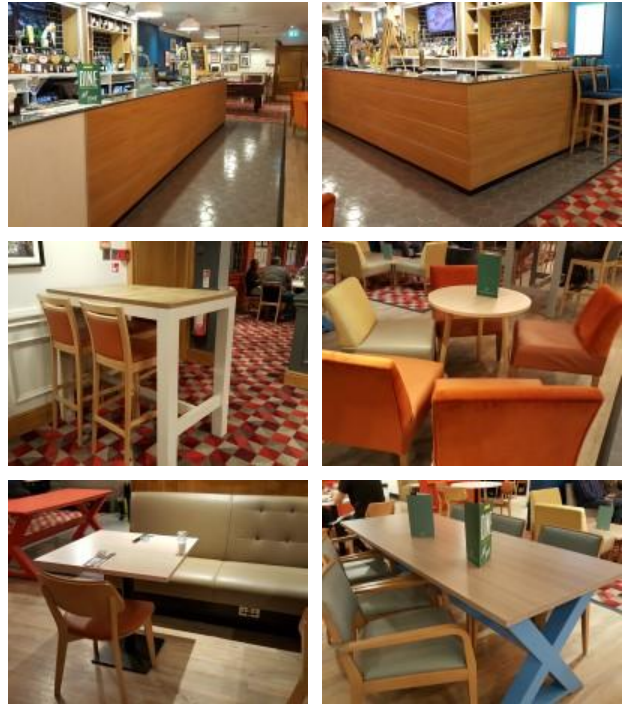
Eating and Drinking (Open Lobby)

- The following information is for the restaurant/bar.
- The restaurant/bar is located ahead as you enter the hotel.
- There is step free access to the restaurant/bar.

- Full table service is available.
- There is not a hearing assistance system.
- There is step free access within the restaurant/bar.
- There is ample room for a wheelchair user to manoeuvre.

- This area does play background music.
- The type of flooring in this area is carpet, tiles and wood.
- No tables are permanently fixed.
- Some chairs are permanently fixed.

- Some chairs have armrests on both sides.
- The nearest table is approximately 3m from the entrance/opening.
- The nearest table is approximately 3m from the till/counter.

- The distance between the floor and the lowest table is 37cm.
- The distance between the floor and the highest table is 101cm.
- The standard height for tables is 68cm.

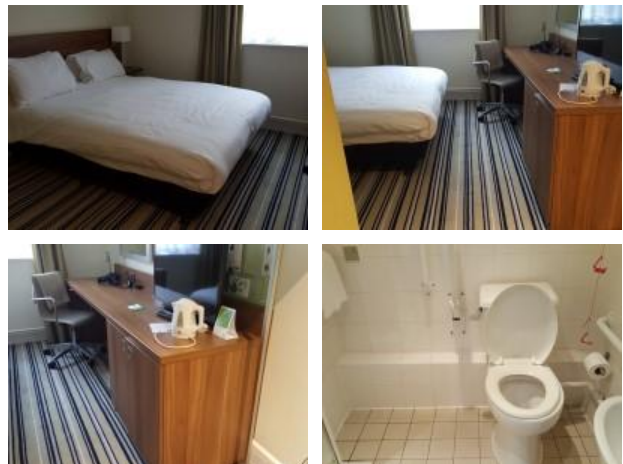
Accessible Room(s) (Rooms 013 and 016)

- The details in this section relates to the accessible room(s) with a wet room/wheel in shower.
- This type of accessible room is located on the ground floor.
- There is step free access to this type of accessible room.
- All accessible rooms of this type have identical specifications.
- The ensuite transfer space for the accessible rooms varies from left to right.
- Guests do not need to open a door between the entrance and the room(s).

- The narrowest width of the corridor leading to the room surveyed was 128cm.
