## Holiday Inn Leeds - Garforth Leisure Facilities

Guide Last Updated: 25/10/2017

## Access Guide

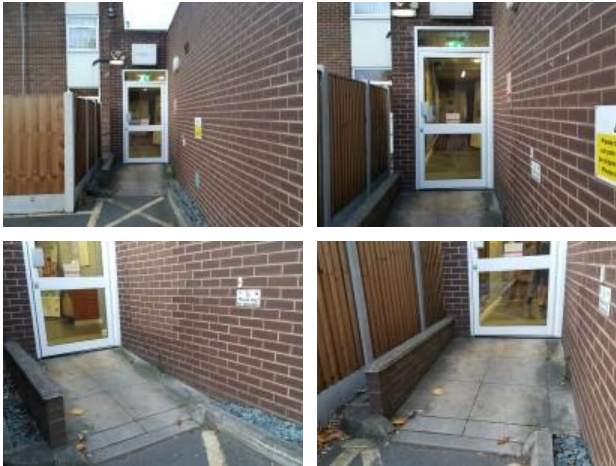
<p>Entrance</p> <p style="text-align: right;">Collapse -</p> <ul style="list-style-type: none"> <li>• This information is for the entrance located at the left hand side of the main hotel.</li> <li>• The entrance area/door is clearly signed.</li> <li>• There is ramped/sloped access at this entrance.</li> <li>• There is not a canopy or recess which provides weather protection at this entrance.</li> <li>• The entrance door(s) does/do contrast visually with its immediate surroundings.</li> <li>• The main door(s) open(s) towards you (pull).</li> <li>• The door(s) is/are single width.</li> <li>• The door(s) is/are heavy.</li> <li>• The width of the door opening is 94cm.</li> </ul>

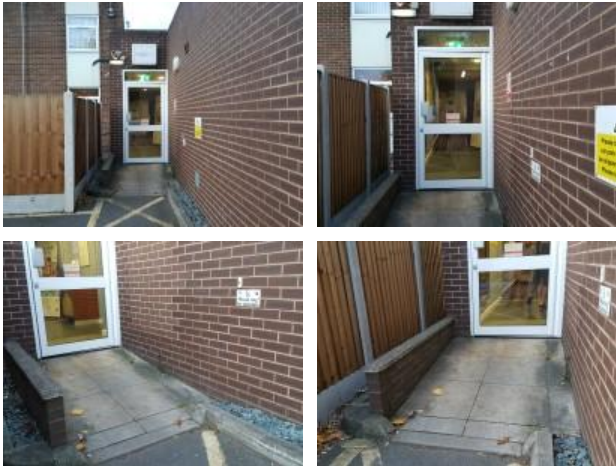
<p>Ramp/Slope</p> <p style="text-align: right;">Collapse -</p> <p>Cookie Policy</p> <p>ated in front of the entrance.</p>

- The gradient of the ramp/slope is steep.
- The ramp/slope is permanent.
- There is not a level landing at the top of the ramp/slope.
- There is not a/are not handrail(s) at the ramp.
- The width of the ramp/slope is 138cm (4ft 6in).

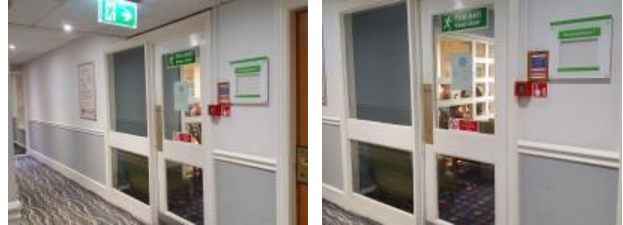
- This information is for the entrance located on the ground floor, in the left hand corridor of the hotel.
- The entrance area/door is clearly signed.
- There is step free access at this entrance.
- The entrance door(s) does not/do not contrast visually with its immediate surroundings.
- The main door(s) open(s) away from you (push).
- The door(s) is/are single width.
- The door(s) is/are heavy.
- The width of the door opening is 82cm.

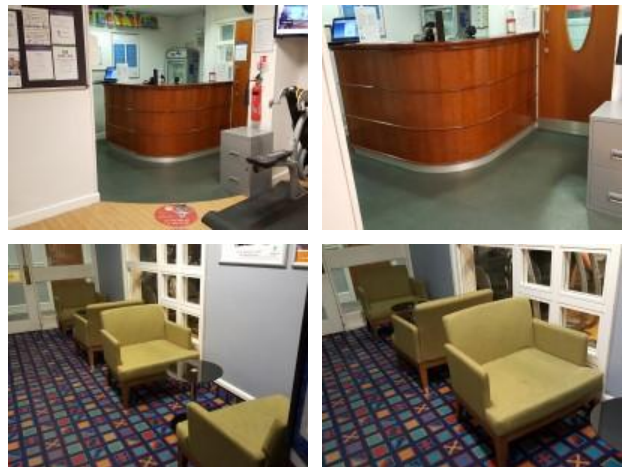
- The lighting levels at the reception point are good.
- The height of the reception counter is high (110cm+).
- There is sufficient space to write or sign documents on the counter.

- There is not a lowered section of the counter.
- The counter is staffed.
- Clipboards can be provided to anyone who is unable to use the desk.
- There is not a hearing assistance system at the reception point.

- Signs and universally accepted symbols or pictograms, such as those for disabled access, WCs, circulation routes and other

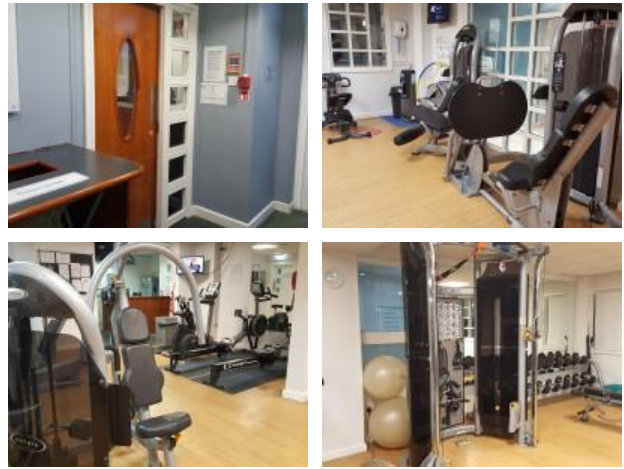
Access to Fitness Suite	Collapse -
<ul style="list-style-type: none"> <li>The fitness suite is located to the left as you enter the leisure facilities.</li> <li>The fitness suite is 7m (7yd 1ft) from the leisure facilities internal hotel entrance.</li> <li>There is level access to the fitness suite.</li> <li>There are doors into the fitness suite.</li> <li>The doors open away from you (push).</li> <li>The doors are single.</li> <li>The doors are heavy.</li> <li>The opening is 73cm (2ft 5in) wide.</li> </ul>	
Fitness Suite (General)	Collapse -
<ul style="list-style-type: none"> <li>Staff receive some training in assisting disabled people.</li> <li>Training provided is in house.</li> <li>Equipment suitable for mobility or sensory impaired users includes free weights, cable pulley machine, upper body machines, and a hand bike.</li> <li>A portable hearing loop is not available for induction.</li> <li>There is clear manoeuvring space between equipment.</li> <li>There is level access to all of the equipment.</li> </ul>

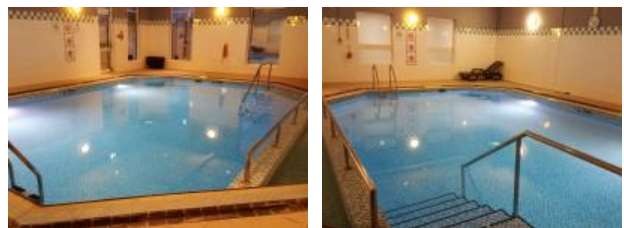
- There is not level access from the changing area to the swimming pool.
- There is not a ramped entrance into the water.
- There is a wet side chair available.
- There is not a hoist for wheelchair users to access the water.
- There are steps into the swimming pool.
- There are 7 steps.
- There is a ladder type entrance into the water.
